Level crossing problems solved

There's nothing particularly special about the level crossing at Ashwell, just north of Oakham in the county of Rutland. Adjacent to Ashwell signal box, this MCB (Manually Controlled Barriers) crossing takes the Whissendine road across the twin-track railway that forms the diversionary route off the Midland main line at Syston through Melton Mowbray and Oakham to Corby. A picturesque line, it can add an hour to a journey to London when the MML is closed for work on a Sunday.

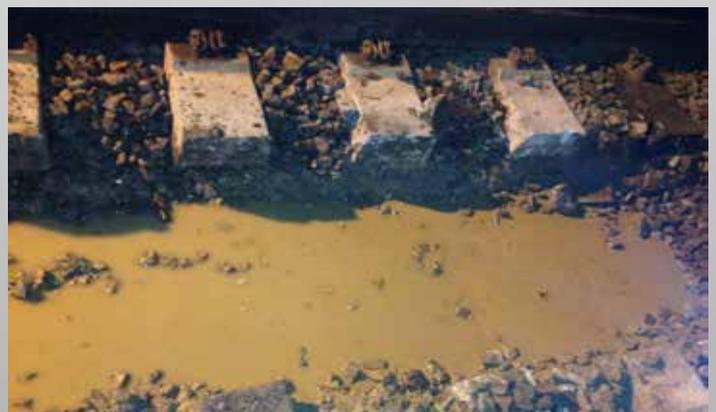
However, in the middle of the six-foot, the excavators struck water. Not just dampness, but a mini-lake that filled the space where the new cills would rest. There was no way that the semi-dry mortar bed could go down in the middle of all that water.

way to drain off the water, so the ballast was excavated deeper to give a firm base. A bed of concrete was poured with its top surface proud of the water level. Despite being underwater, the concrete would set – given time.

Meanwhile, a lorry was despatched back to Doncaster to go and raid the RRAP hire stock. It returned three hours later with a load of rubber Strail cess panels.

A temporary arrangement was put together for the six-foot whereby the fresh concrete was protected by a sheet of Visqueen waterproof membrane. This was then covered with a type 1 aggregate infill, compacted in layers, and then the rubber panels were placed over that with a temporary infill of Instarmac Ultracrete cold lay asphalt behind the temporary Strail panels.

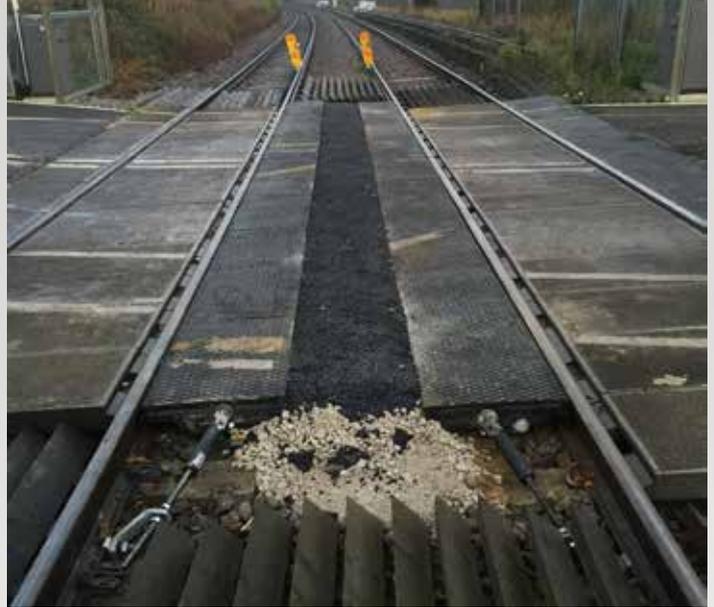
When the team returned for a second weekend, and stripped the rubber panels and temporary asphalt out of the six-foot, the concrete was "rock solid", to quote Premier Rail director David Claridge.

A fresh semi-dry mortar bed was laid and a total of twelve new cill beams were bedded into position. Once they were in place, the void between them was filled with concrete and topped up with 60-70mm of new Instarmac Ultracrete coldlay tarmac. This was a temporary measure until the carriageway was planed and resurfaced along with white lining.

By now, all of the other work had been completed. The crossing was now a Polysafe crossing system throughout. New wooden anti-ingress panels had also been installed to stop pedestrians and animals from accessing the running lines from the crossing.
